**Subject: Emergency Response Trip Report and Removal Site Evaluation
 Park Warehouse Fire Site, St. Louis, Missouri
 U.S. EPA Region 7 START 4, Contract No. EP-S7-13-06, Task Order No. 0203
 Task Monitor: Heath Smith, EPA On-Scene Coordinator**

**EMERGENCY RESPONSE TRIP REPORT AND REMOVAL SITE EVALUATION
PARK WAREHOUSE FIRE, ST. LOUIS, MISSOURI**

**Superfund Technical Assessment and Response Team (START) 4 Contract
Contract No. EP-S7-13-06, Task Order No. 0203**

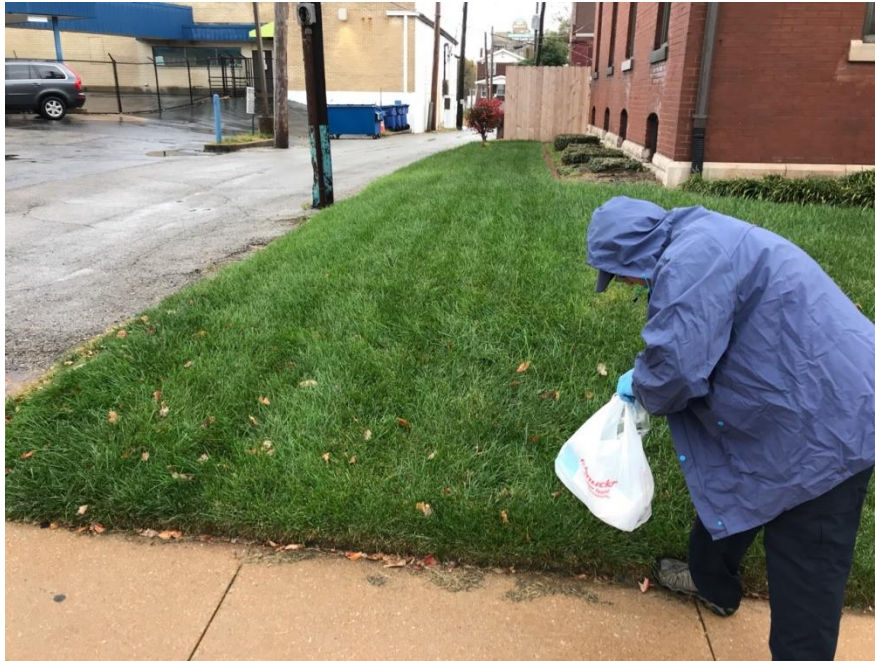
Photo No.: 87	Date: 11/18/2017	Time: 10:30
Photographer: Greg Blattner		Direction: Southeast
Latitude: 38.61900		Longitude: -90.23973
Description: This photograph shows debris sample WF-T1-028 collected from residential neighborhood near Park Warehouse.

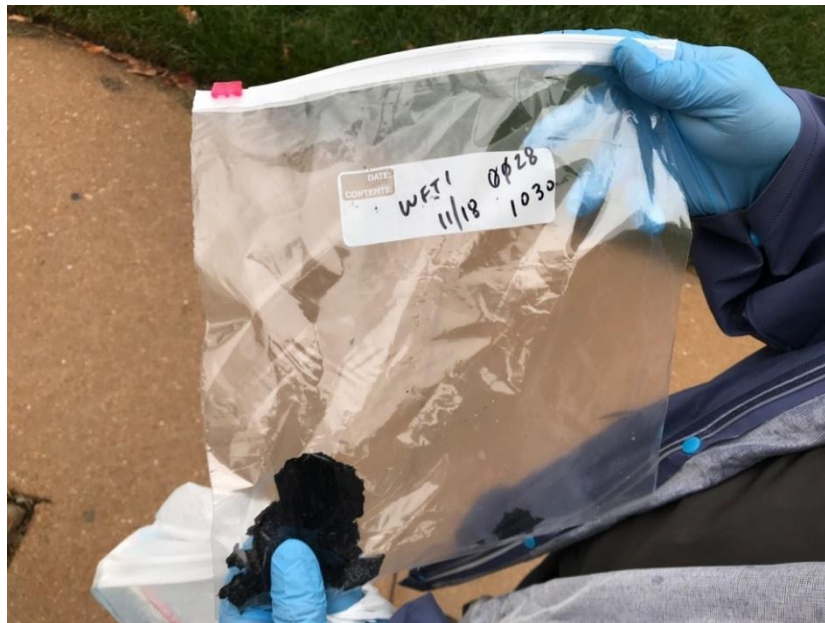
Photo No.: 88	Date: 11/18/2017	Time: 10:30
Photographer: Greg Blattner		Direction: Southeast
Latitude: 38.61900	Longitude: -90.23973	
Description: This photograph shows debris sample WF-T1-028 collected from residential neighborhood near Park Warehouse.

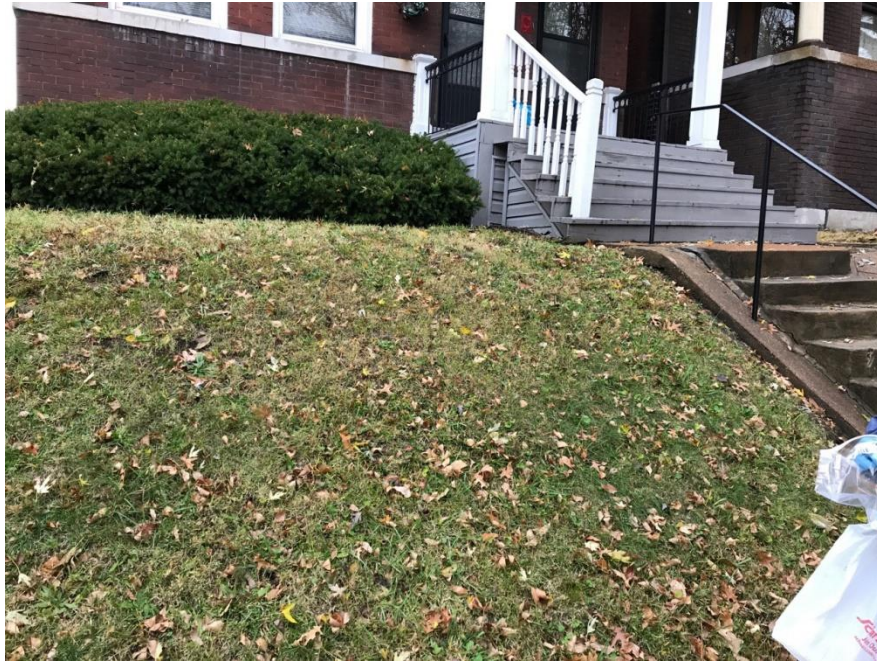
Photo No.: 89	Date: 11/18/2017	Time: 10:35
Photographer: Greg Blattner		Direction: North
Latitude: 38.61928		Longitude: -90.24142
Description: This photograph shows debris sample WF-T1-029 collected from residential neighborhood near Park Warehouse.

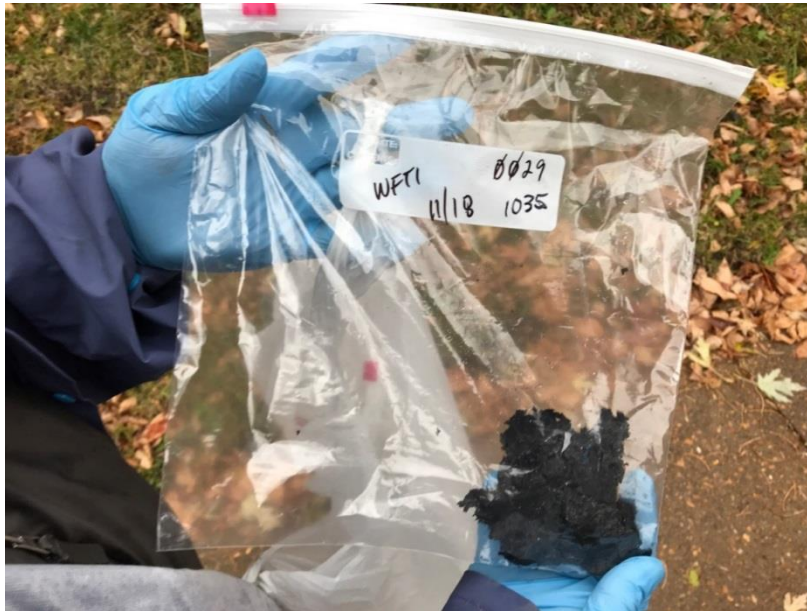
Photo No.: 90	Date: 11/18/2017	Time: 10:35
Photographer: Greg Blattner		Direction: North
Latitude: 38.61928		Longitude: -90.24142
Description: This photograph shows debris sample WF-T1-029 collected from residential neighborhood near Park Warehouse.

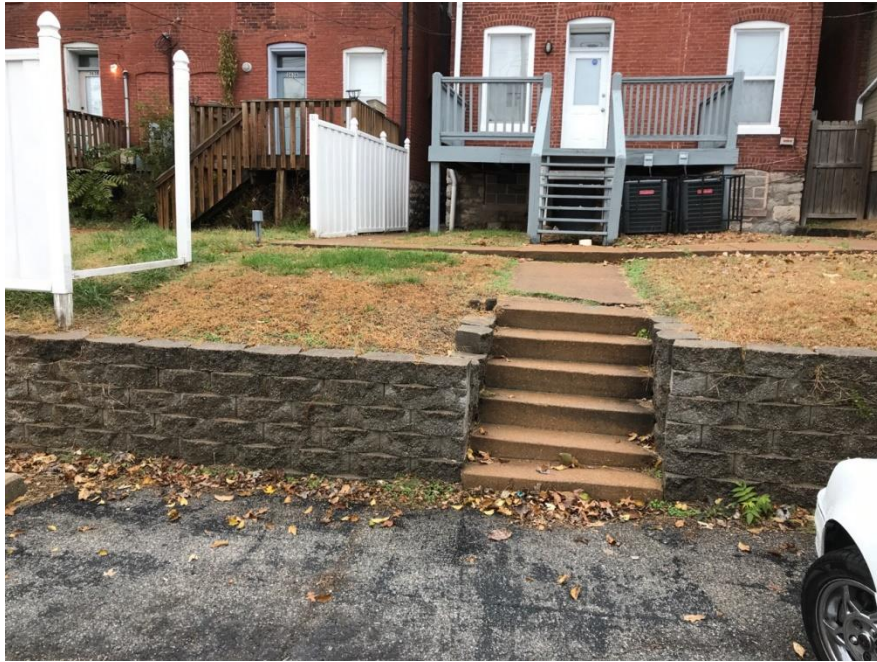
Photo No.: 91	Date: 11/18/2017	Time: 10:45
Photographer: Greg Blattner		Direction: Southeast
Latitude: 38.61874		Longitude: -90.24038
Description: This photograph shows debris sample WF-T1-030 collected from residential neighborhood near Park Warehouse.

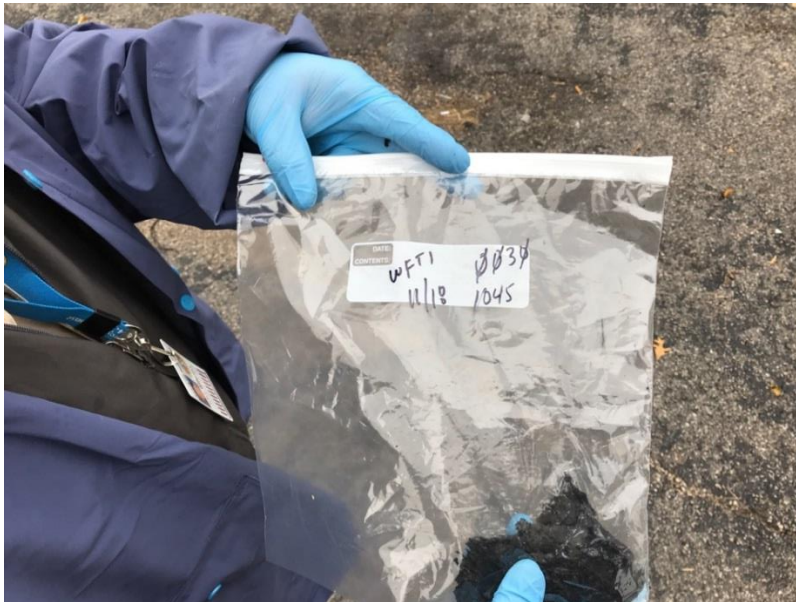
Photo No.: 92	Date: 11/18/2017	Time: 10:45
Photographer: Greg Blattner		Direction: Southeast
Latitude: 38.61874	Longitude: -90.24038	
Description: This photograph shows debris sample WF-T1-030 collected from residential neighborhood near Park Warehouse.

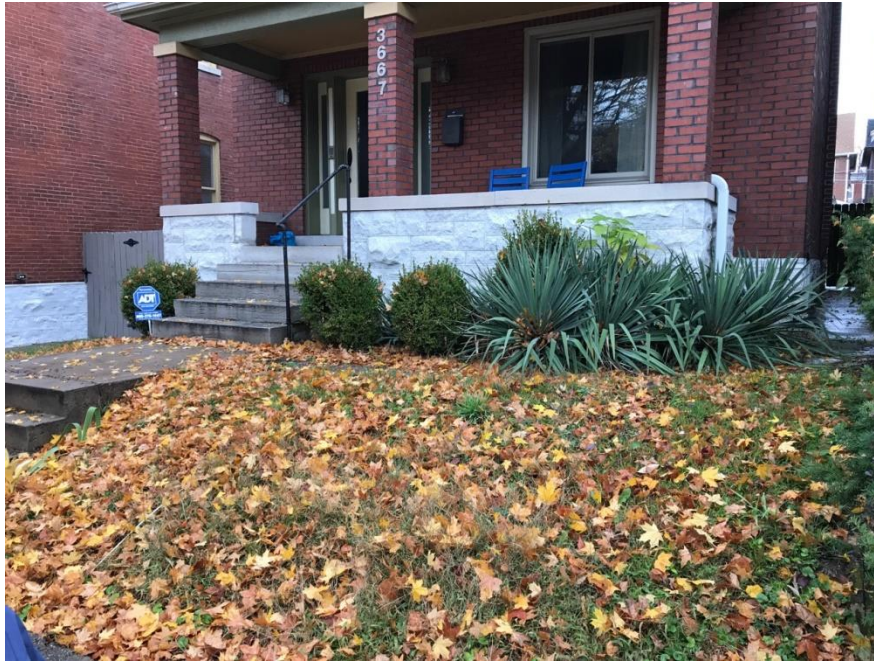
Photo No.: 93	Date: 11/18/2017	Time: 11:00
Photographer: Greg Blattner		Direction: North
Latitude: 38.61839		Longitude: -90.24255
Description: This photograph shows debris sample WF-T1-031 collected from residential neighborhood near Park Warehouse.

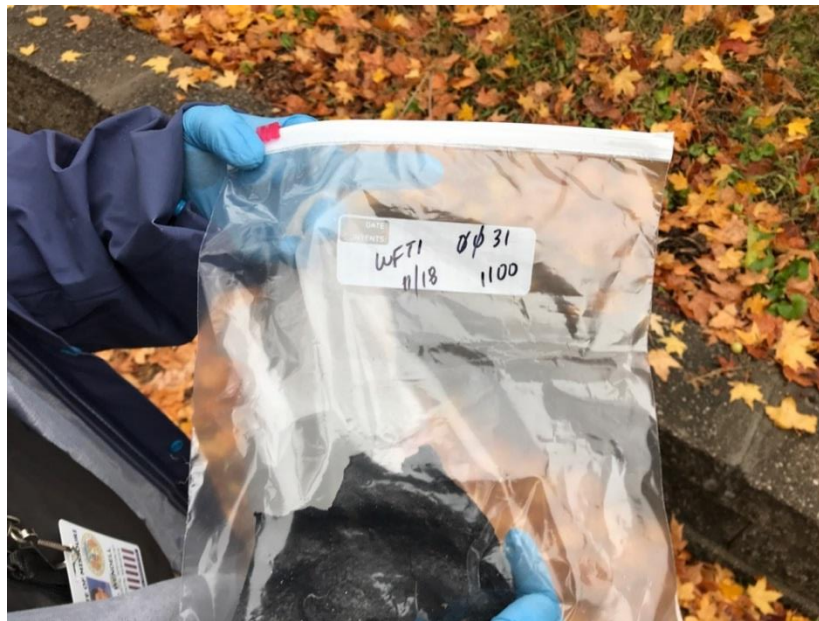
Photo No.: 94	Date: 11/18/2017	Time: 11:00
Photographer: Greg Blattner		Direction: North
Latitude: 38.61838		Longitude: -90.24155
Description: This photograph shows debris sample WF-T1-031 collected from residential neighborhood near Park Warehouse.

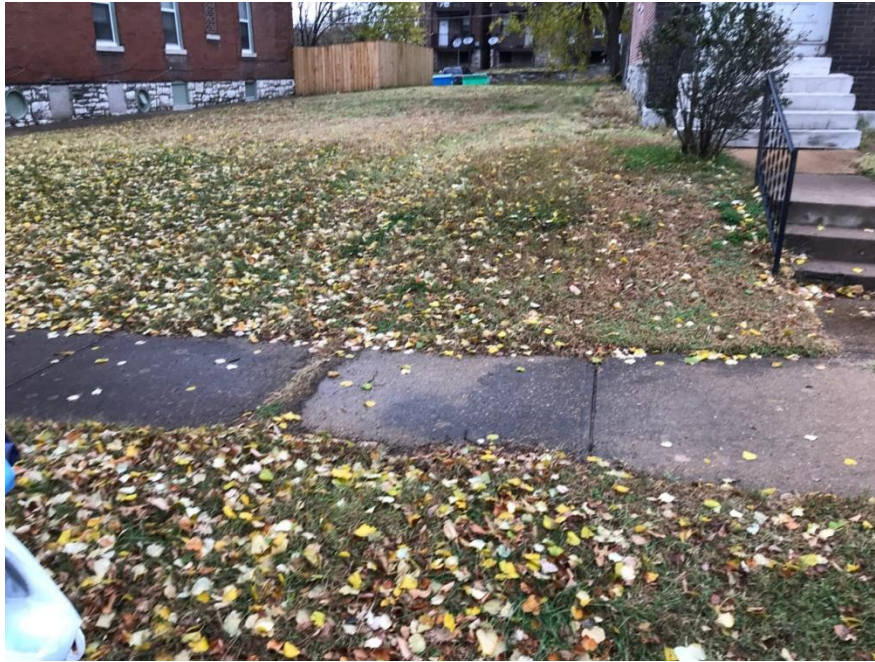
Photo No.: 95	Date: 11/18/2017	Time: 11:10
Photographer: Greg Blattner		Direction: North
Latitude: 38.61959		Longitude: -90.24411
Description: This photograph shows debris sample WF-T1-032 collected from residential neighborhood near Park Warehouse.

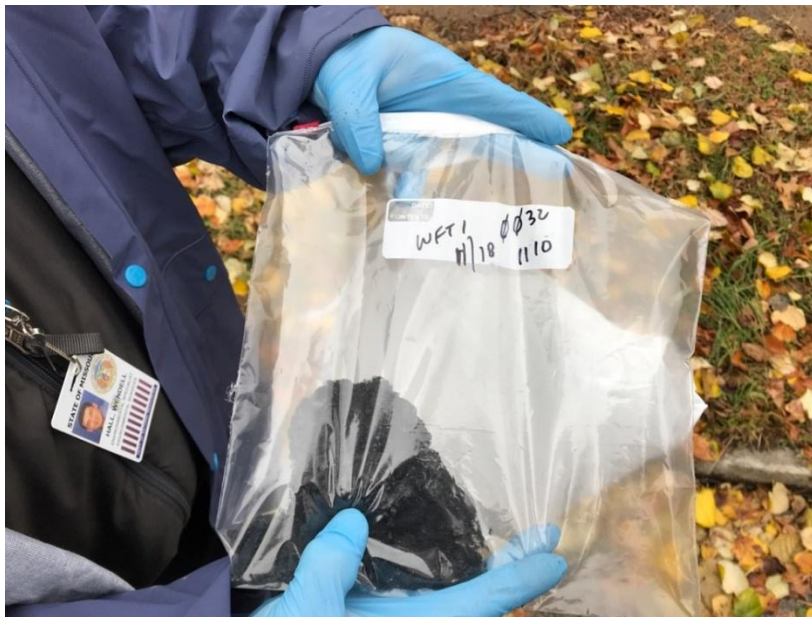
Photo No.: 96	Date: 11/18/2017	Time: 11:10
Photographer: Greg Blattner		Direction: North
Latitude: 38.61959	Longitude: -90.24411	
Description: This photograph shows debris sample WF-T1-032 collected from residential neighborhood near Park Warehouse.

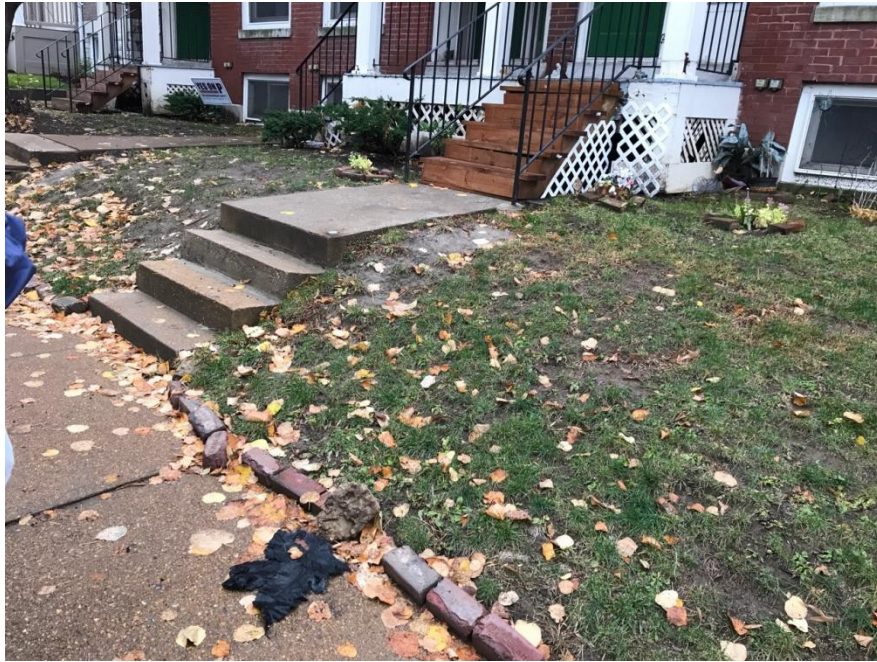
Photo No.: 97	Date: 11/18/2017	Time: 11:15
Photographer: Greg Blattner		Direction: Southeast
Latitude: 38.61932	Longitude: -90.24346	
Description: This photograph shows debris sample WF-T1-033 collected from residential neighborhood near Park Warehouse.

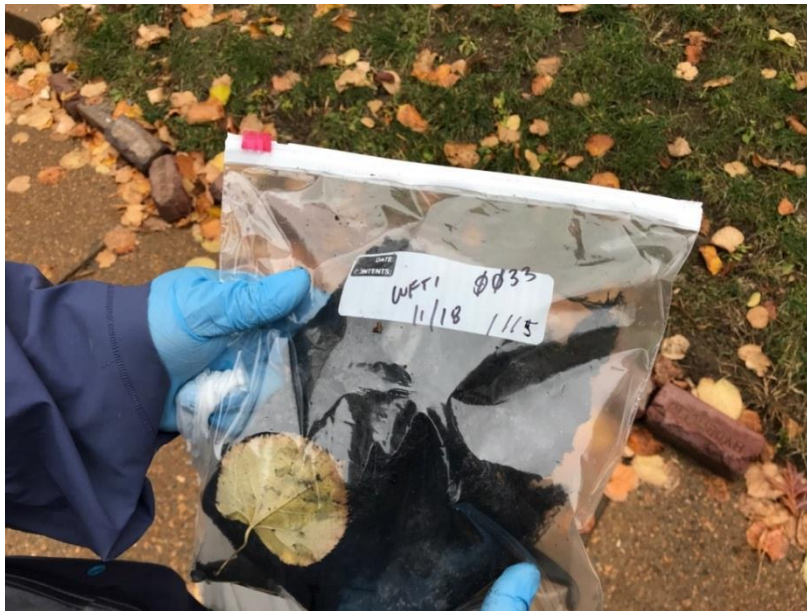
Photo No.: 98	Date: 11/18/2017	Time: 11:15
Photographer: Greg Blattner		Direction: Southeast
Latitude: 38.61932	Longitude: -90.24346	
Description: This photograph shows debris sample WF-T1-033 collected from residential neighborhood near Park Warehouse.
